EGG-TMI-6859

May 1985

COMPUTER CODE CALCULATIONS OF THE TMI-2 ACCIDENT:
INITIAL AND BOUNDARY CONDITIONS

Idaho National Engineering Laboratory

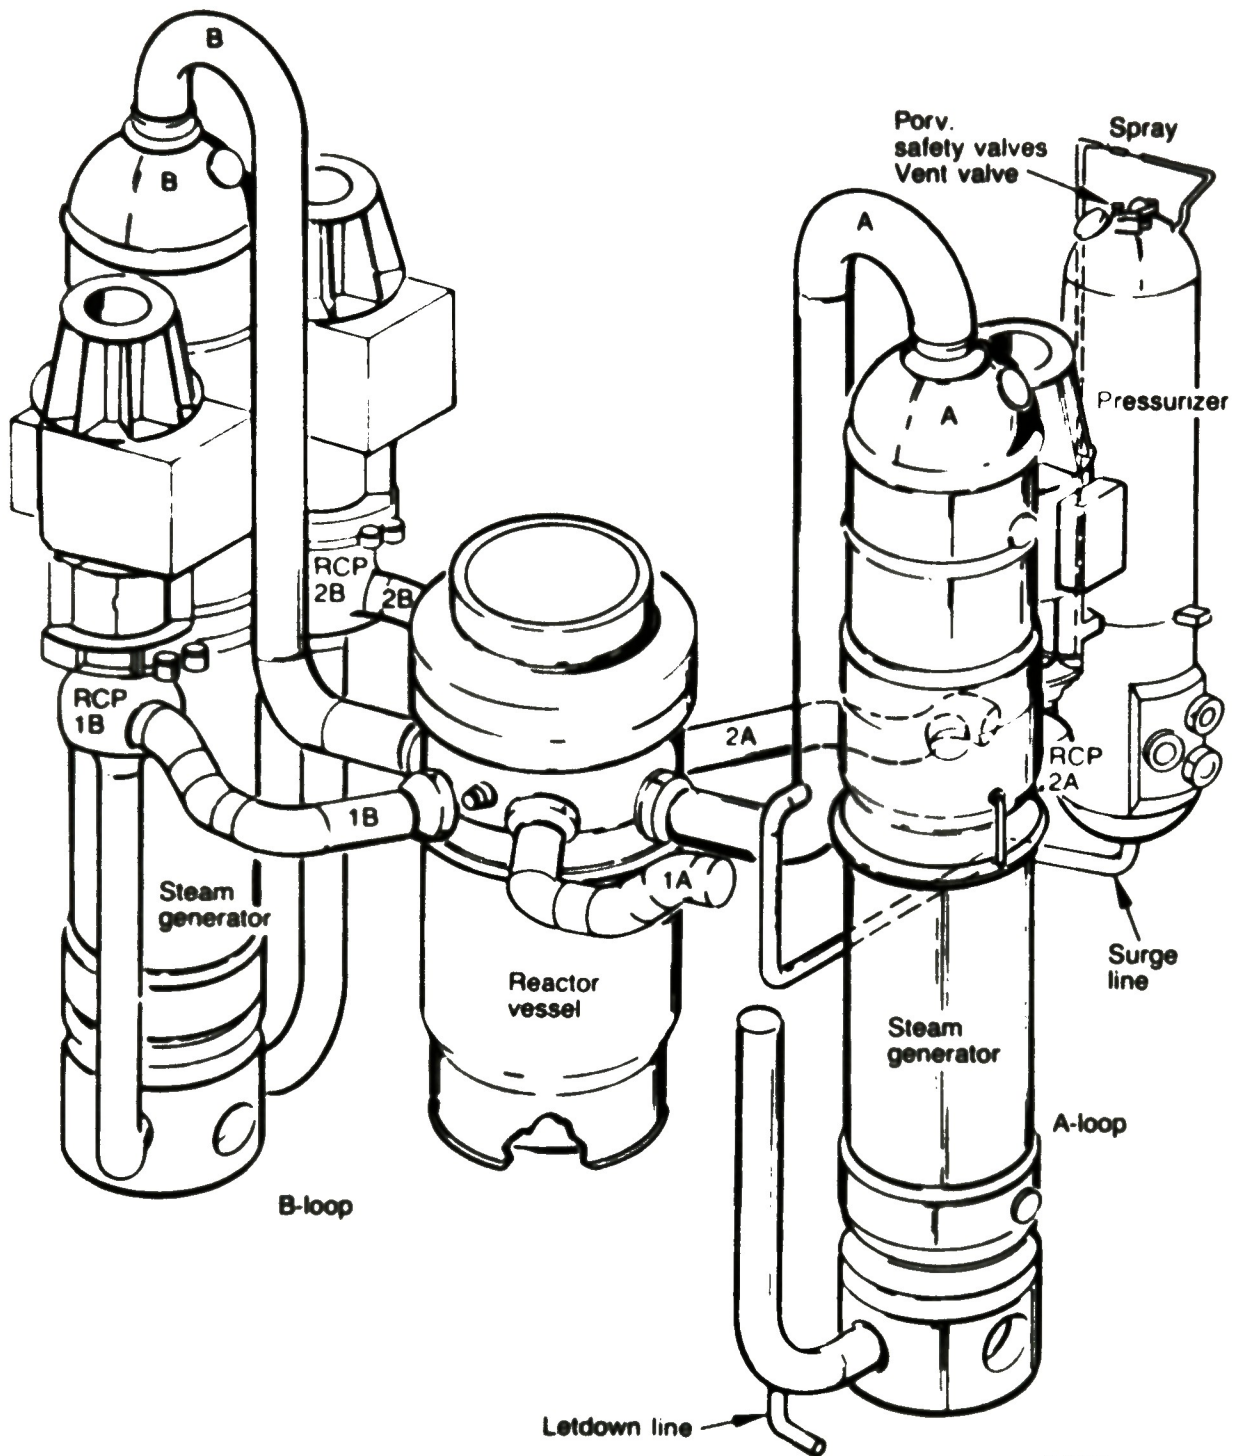
Figure 1. Schematic drawing of the TMI-2 reactor coolant system.

The orientation of the pressurizer surge line connection to the side of the A loop hot leg can be seen in Figure 1. The connection is just downstream of a 90-degree bend. The phase separation of the relatively high velocity liquid-vapor stream in this bend during two-phase pump operation should be accounted for when calculating the flow into the surge line.

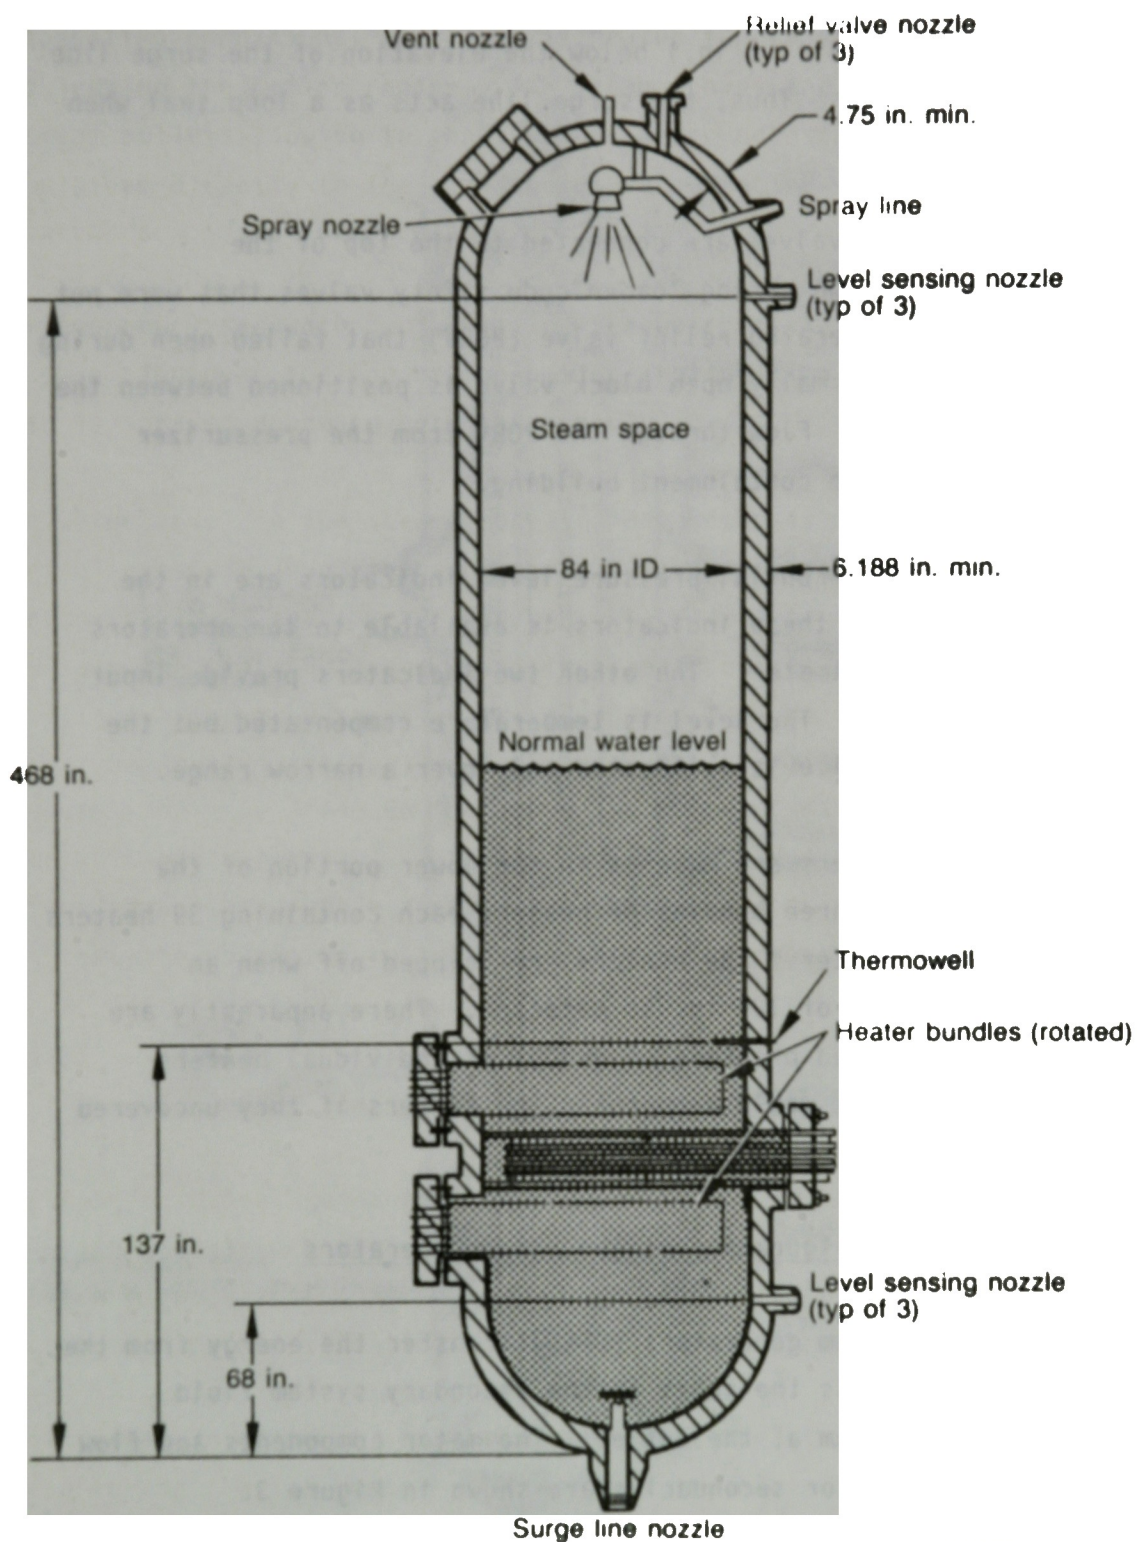
Figure 2. TMI-2 pressurizer.

The pressure relief valves are connected to the top of the pressurizer. There are two spring loaded code safety valves that were not challenged and a pilot-operated relief valve (PORV) that failed open during the TMI-2 accident. A normally open block valve is positioned between the pressurizer and the PORV. Flow through the PORV from the pressurizer enters a drain tank in the containment building.

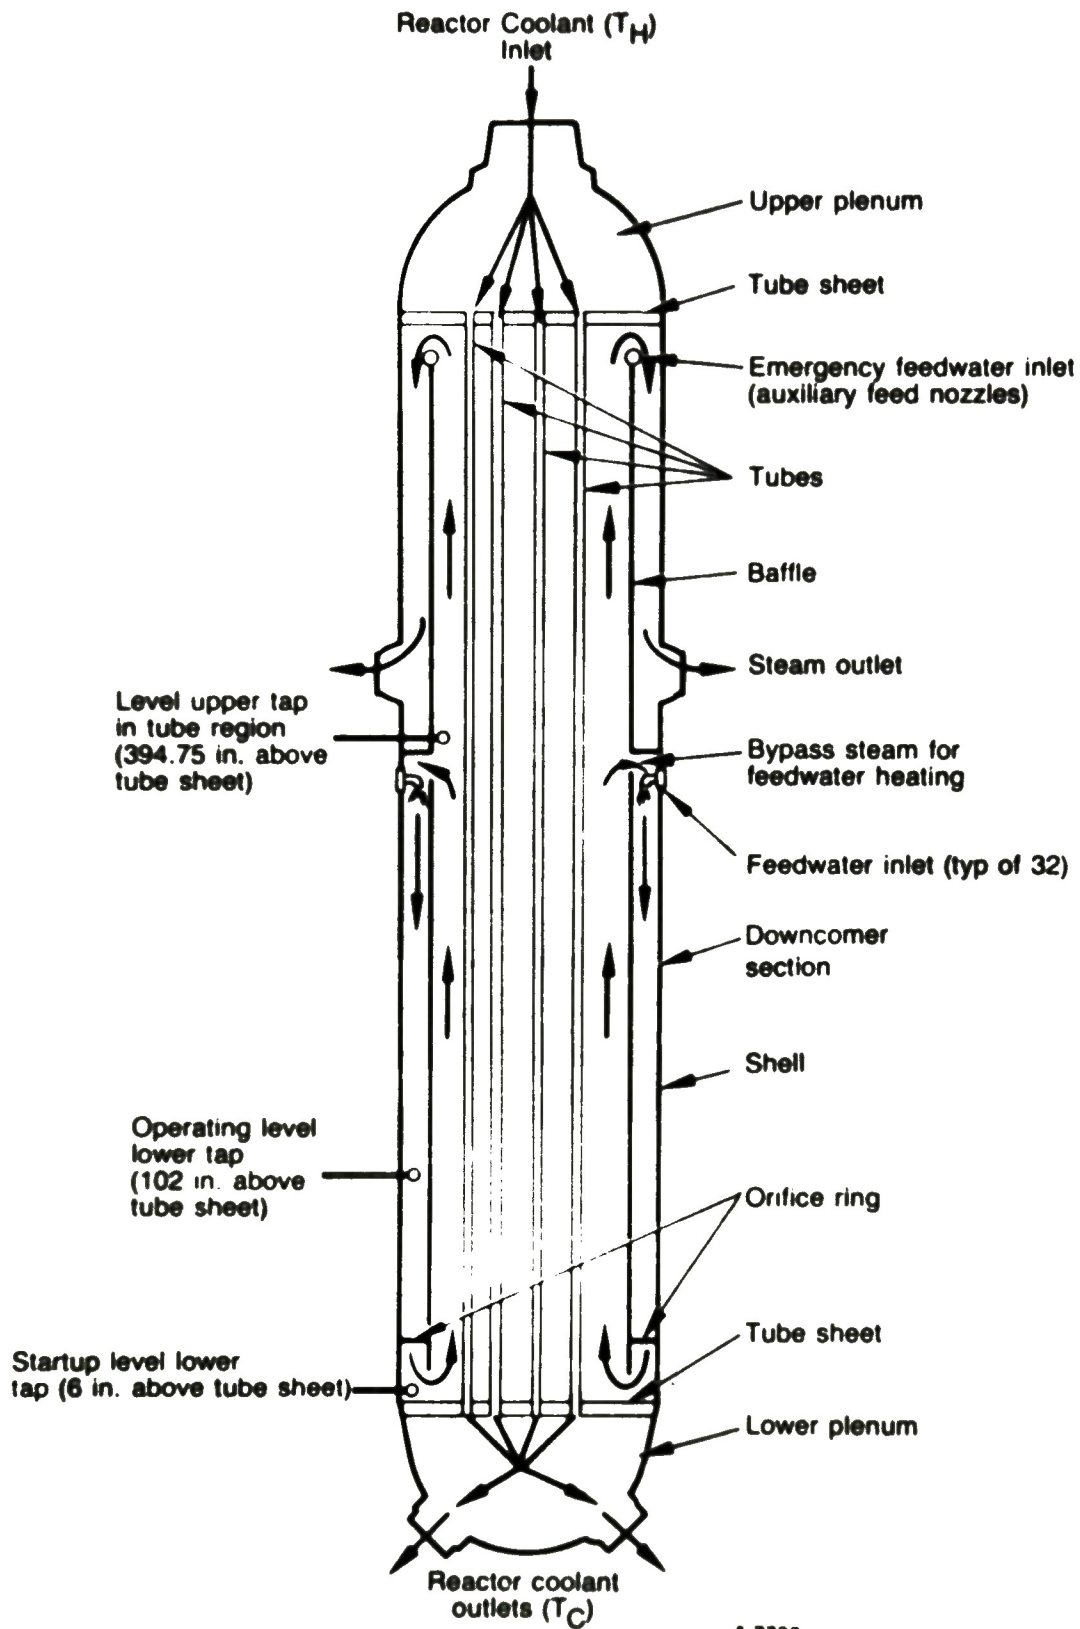
Figure 3. TMI-2 once through steam generator.

The water level in the steam generator downcomer is measured using differential pressure level transducers. Two measurements that were recorded on the TMI-2 reactimeter during the accident for each steam generator are the start-up range level that measures the downcomer level from 6 in. above the tube sheet in the downcomer to a height 394.75 in. above the tube sheet in the boiler region and the operating range level that measures the level from 96 in. above the start-up range lower tap to the start-up range upper tap. The operating range level measurement is temperature compensated while the startup range level measurement is not. The fact that the upper tap is in the boiler region means the instrument readings are effected by the flow friction.

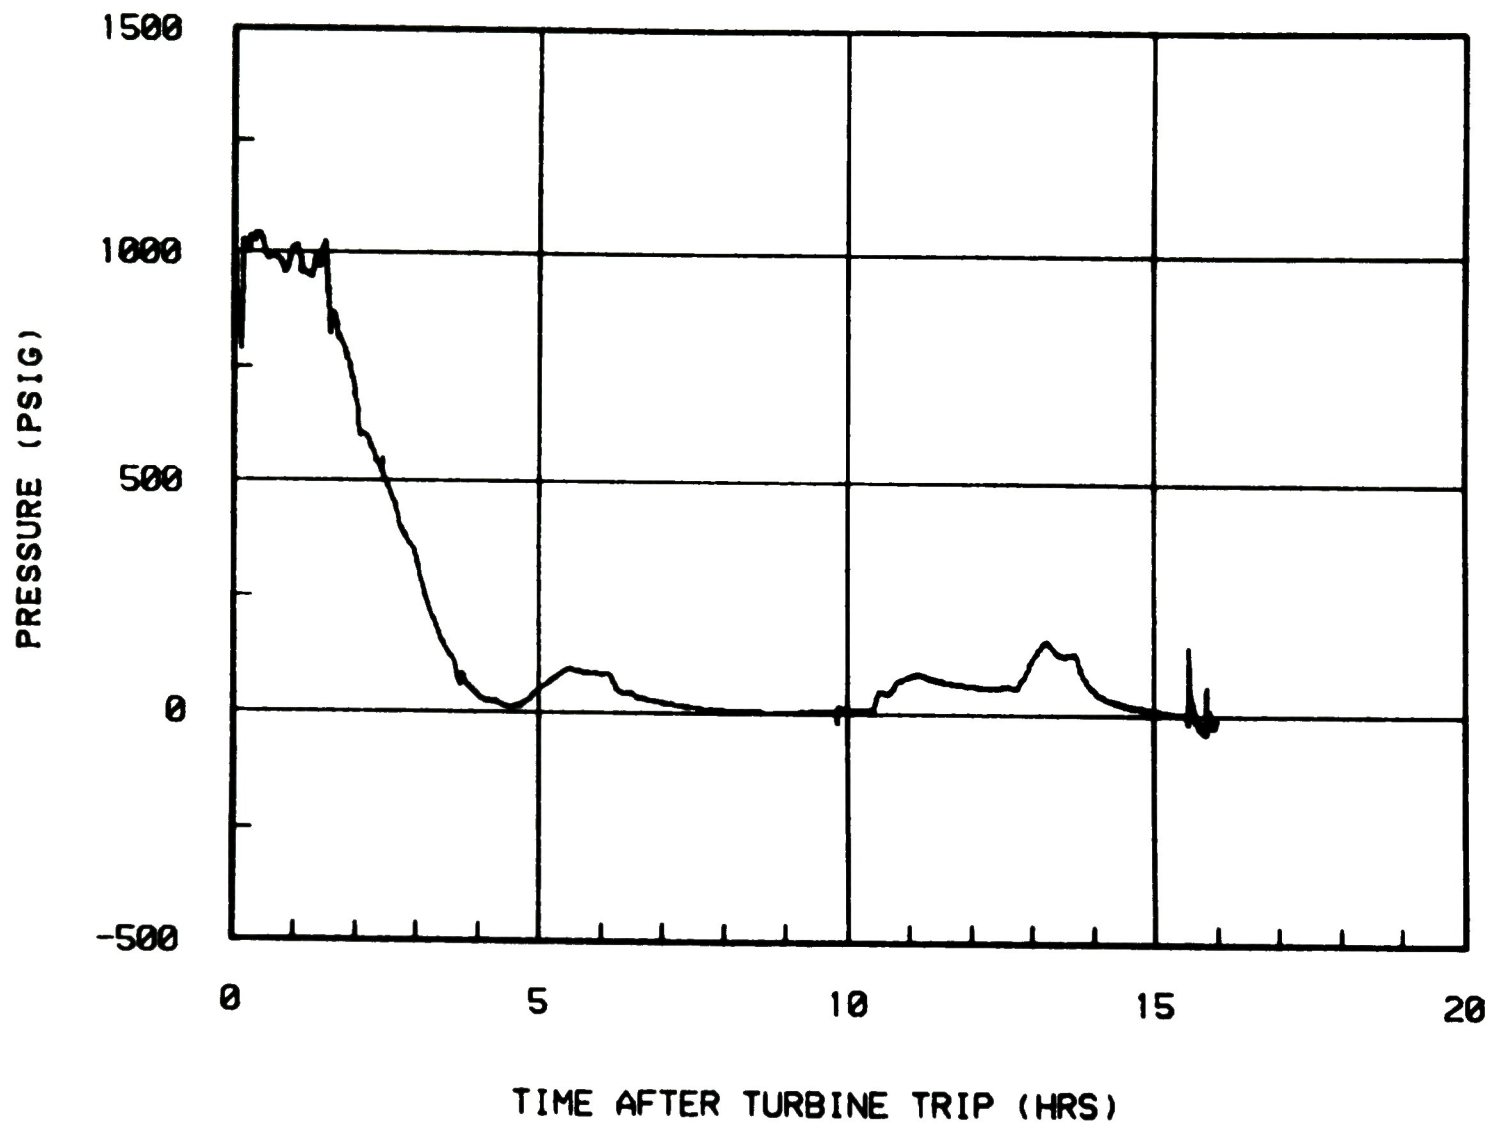
Figure 4. A-Loop Steam Generator Secondary Pressure -- Long Term.

The pressure and water level changed throughout the transient. These parameters were recorded on the plant reactimeter and are shown on several figures. Figure 4 shows the pressure in the A-loop steam generator secondary from the start of the accident until 16 h. Figure 5 shows the same information for the first 5 h after turbine trip. Figure 6 and 7 show the pressure in the B-loop steam generator for 0 to 16 h and 0 to 5 h respectively. Figures 8 and 9 are the long term and short term recorded startup level (maximum reading of 250 in.) for the A-loop steam generator. Figures 10 and 11 are the long and short term operating range level for the A-loop steam generator. Figures 12 through 15 are similar figures for the B-loop generator. The operating level reading is temperature compensated while the startup level reading is not. Thus the two level measurements are not identical. It is recommended the operating level be used unless that level is less than about 10% when the startup level should be used (see Section 3.4).
